Facility: Des Joachims GS Page: 1 of 8

BUSINESS CASE SUMMARY
Replace Main Output Transformers

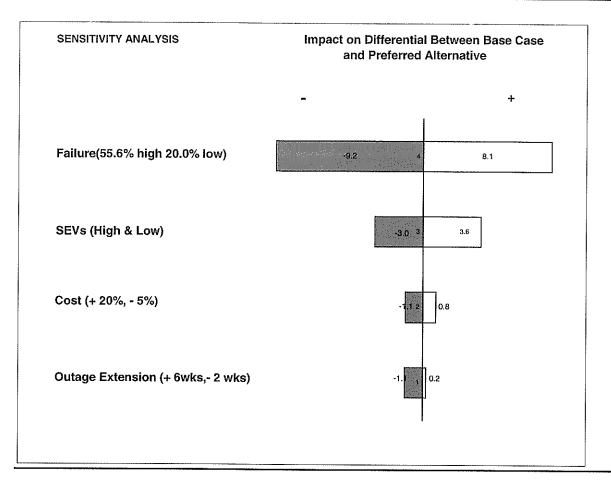
The results of the sensitivity analysis are shown in the diagram below. This shows the variance from the Base Case to the preferred option (Alt. 3) resulting from changes to Failure Probability, Cost, Outage Time and SEV's. Difference from the Base Case to the preferred option is (\$8.1M) based on a 55.6% failure rate assumption. The diagram illustrates that Probability of Failure represents the greatest risk of influencing the NPV value with Cost and Outage Time expected to present the least risk.

VARIABLE/RISK	HIGH/LOW RANGES	NPV	NPV	+/- From Initial
		(2007 \$M)	(2007 \$M)	Difference
		Base Case	Preferred	Between Base
			Alternative	Case & Pref. Alt.
				(2007 \$M)
	HIGH 55.6% Failure	-67.5	-52.9	8.1
Probability of failure				
	LOW 20% Failure	-17.5	-20.1	-9.2
	HIGH 20% increase	-32.4	-26.9	-1.1
Cost				
	LOW 5% decrease	-29.8	-22.4	0.8
	HIGH 10 weeks (add'n 6weeks)	-30.7	-25.3	-1.1
Outage Extension				
	LOW 2 weeks (reduce 2 weeks)	-30.2	-23.5	0.2
	High SEVs	-36.3	-26.1	3.6
SEVs				
	Low SEVs	-25.8	-22.3	-3.0
